Inspection Report

Jacksonville FL Strip Mall Building

Strip Mall Inspection

Jacksonville FL 32202

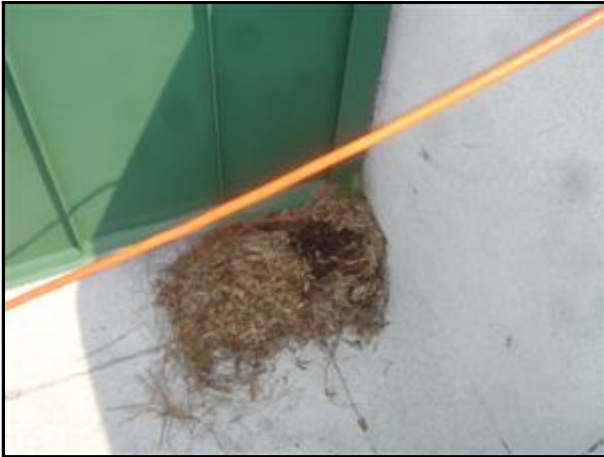
1.0 Item 1(Picture)

(1) Recommend remove all debris from roof.

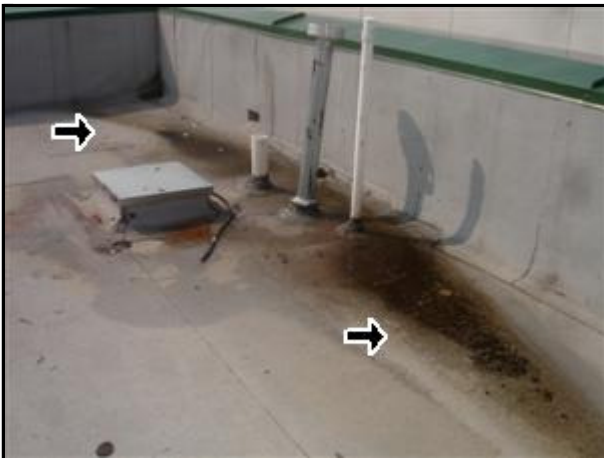
1.0 Item 2(Picture)

(2) Standing water noted at roof mostly at left rear corner of building. Leaking and further damage may occur. Recommend repair by qualified roof contractor.

(2) Standing water noted at roof mostly at left rear corner of building. Leaking and further damage may occur. Recommend repair by qualified roof contractor.
-

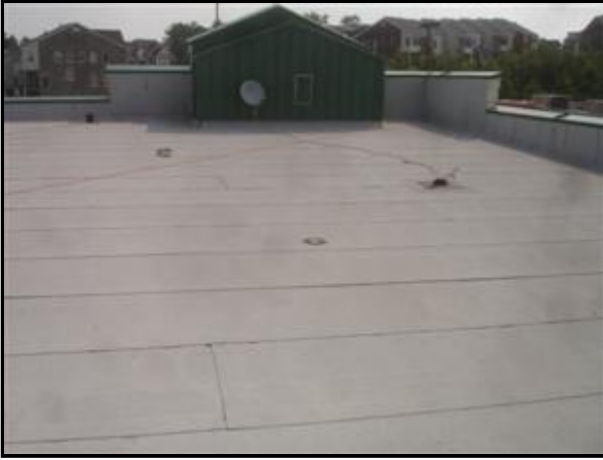
1.0 Item 3(Picture)

(3) Roof covering type for building appeared to be TPO covering. Some small humps or raised sections were noted and may need repair (recommend further evaluation of these areas when roof contractor makes other known defective repairs). Recommend regular evaluation of roof covering by a qualified roof contractor.

(3) Roof covering type for building appeared to be TPO covering. Some small humps or raised sections were noted and may need repair (recommend further evaluation of these areas when roof contractor makes other know defective repairs). Recommend regular evaluation of roof covering by a qualified roof contractor.
-

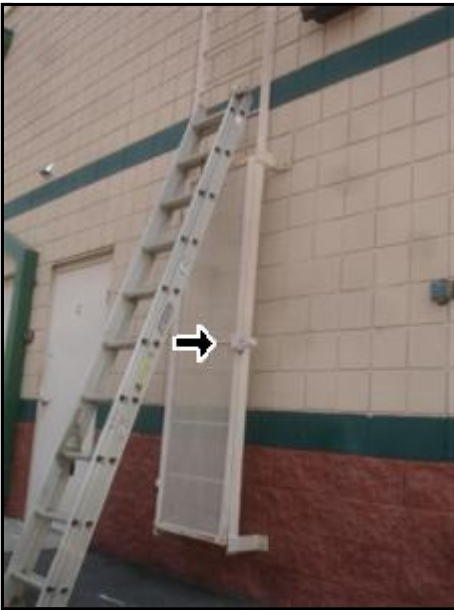
1.0 Item 4(Picture)

(4) Rear building roof service ladder was locked. Recommend obtaining key.

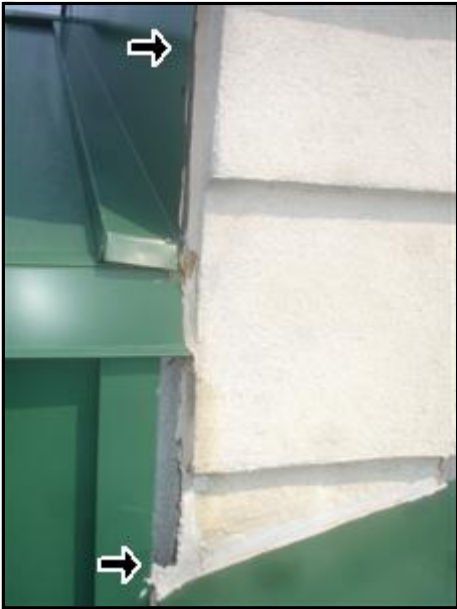
1.1 Item 1(Picture)

Recommend sealing all transitions at roof such as where metal cap meets stucco cladding and where metal cap meets roof covering. Leaking may occur. Recommend repair by qualified roof contractor.

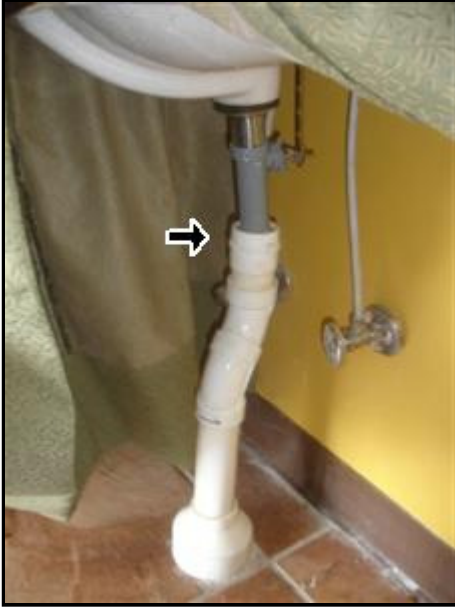
4.0 Item 1(Picture)

- 🏠 (1) Several drain waste lines for sinks did not have visible P-Traps. Recommend repair by licensed plumber.

(1) Several drain waste lines for sinks did not have visible P-Traps. Recommend repair by licensed plumber.
-

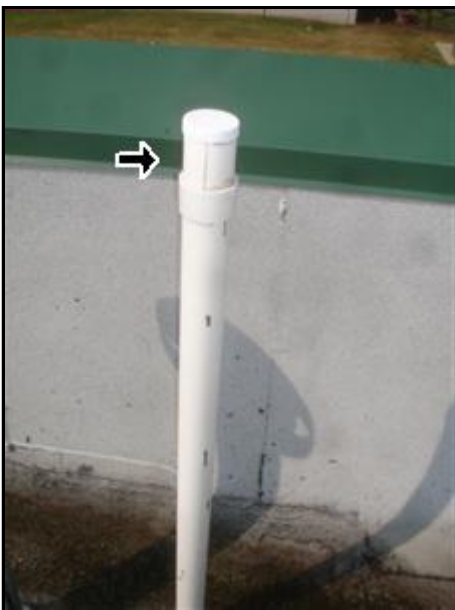
4.0 Item 3(Picture)

- 🏠 (2) Plumbing vent piping was capped off at rear roof of building. Recommend repair by licensed plumber.

(2) Plumbing vent piping was capped off at rear roof of building. Recommend repair by licensed plumber.

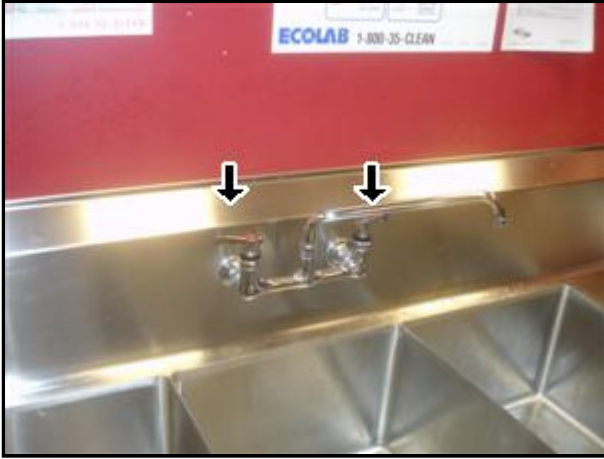
4.1 Item 1(Picture)

Bottom element cover for electric water heater was not properly secured. I noted plumbing water piping for hot and cold was reversed at faucets. Cold water produced luke warm temperatures. Recommend further evaluation and repair by licensed plumber.

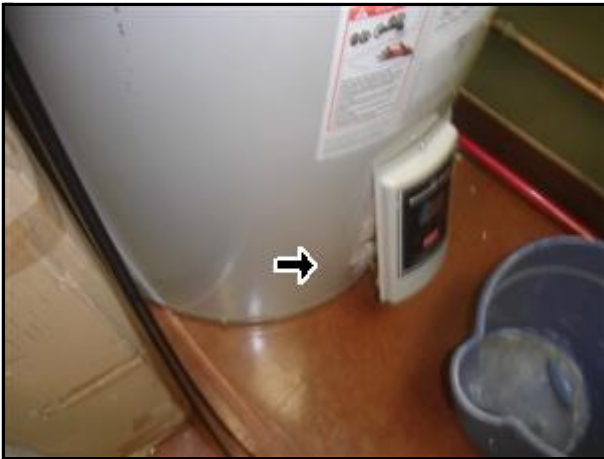
4.2 Item 1(Picture)

Bottom element cover for electric water heater was not properly secured. I noted plumbing water piping for hot and cold was reversed at faucets. Cold water produced luke warm temperatures. Recommend further evaluation and repair by licensed plumber.

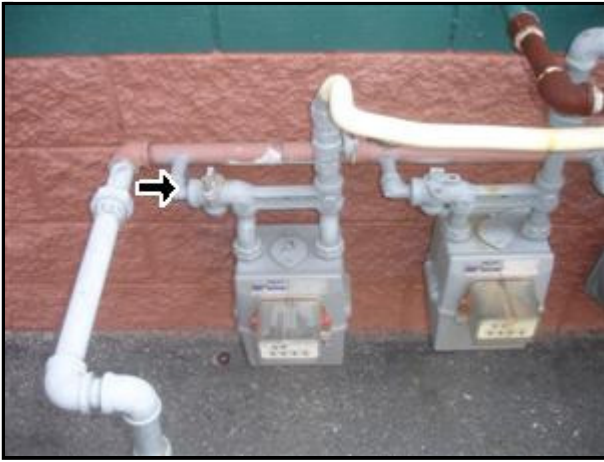
4.4 Item 1(Picture)

Gas was not turned onto building at time of inspection. I could not test any gas operated appliances for proper operation.

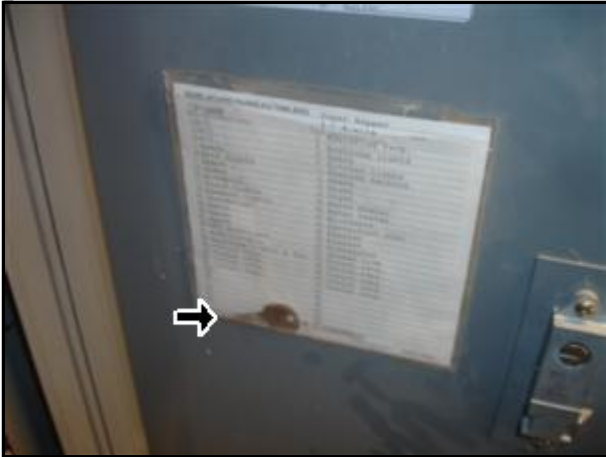
7.1 Item 1(Picture)

Key for electrical access panel (dead cover) was noted inside. Recommend putting key in accessible place if you lock the panel cover.

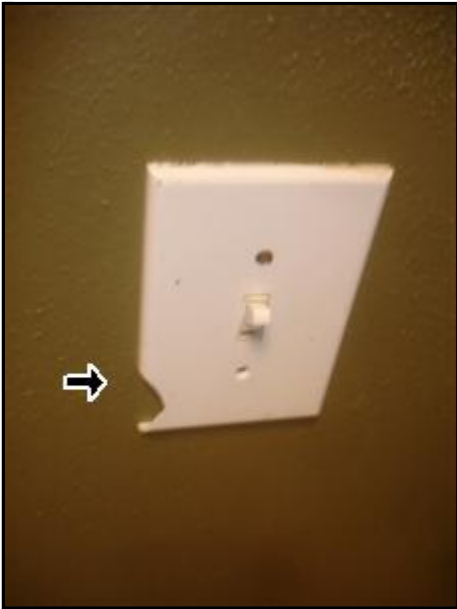
7.3 Item 1(Picture)

(1) Rear private restroom switch plate is damaged. Recommend repair by licensed electrical.

(1) Rear private restroom switch plate is damaged. Recommend repair by licensed electrical.
-

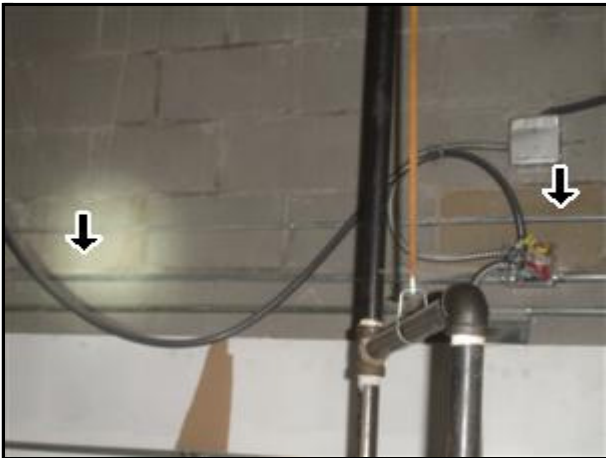
7.3 Item 2(Picture)

(2) Exposed electrical wiring noted in several areas above suspended ceiling inside building. Electrical wiring was also not properly secured. This is a safety issue. Recommend repair by licensed electrical.

(2) Exposed electrical wiring noted in several areas above suspended ceiling inside building. Electrical wiring was also not properly secured. This is a safety issue. Recommend repair by licensed electrical.
-

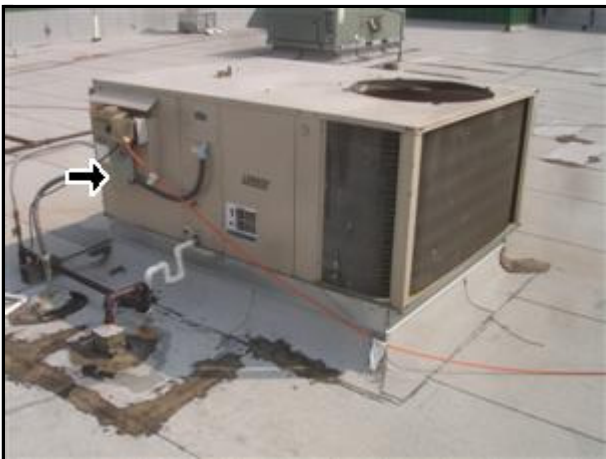
7.3 Item 3(Picture)

(3) Electrical extension cord was plugged into unit B HVAC system on roof. This extension cord is hanging unplugged at the front of your building. Recommend remove extension cord.

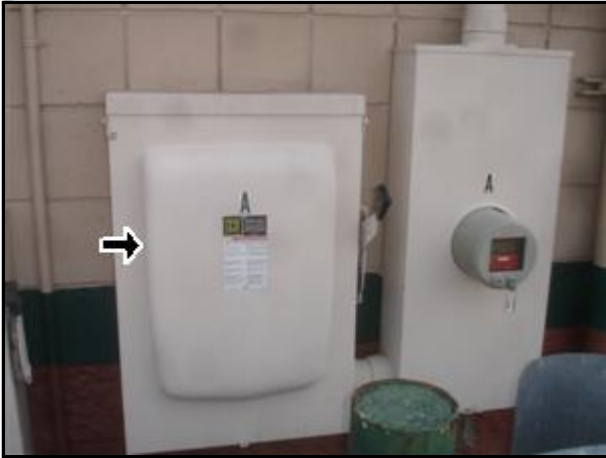
7.6 Item 1(Picture)

The main panel box is located in kitchen area inside. However, the main disconnect (shut-off) is outside at meter base panel (Your unit A for your information).

I was not able to open the main disconnect cover (painted shut) recommend making main disconnect accessible.

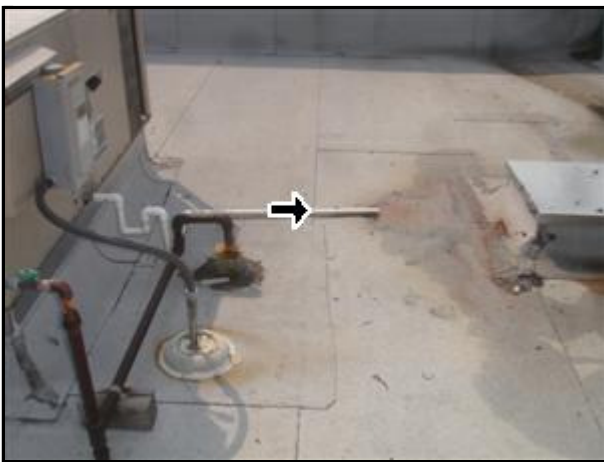
8.2 Item 1(Picture)

- Condensation piping for HVAC unit drains directly onto roof. Recommend extend piping to side of building. Further damage may occur. Recommend repair by licensed HVAC contractor.

Condensation piping for HVAC unit drains directly onto roof. Recommend extend piping to side of building. Further damage may occur. Recommend repair by licensed HVAC contractor.

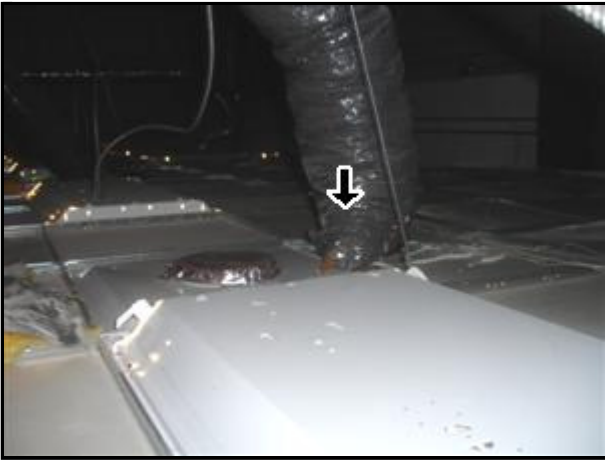
8.6 Item 1(Picture)

- HVAC duct piping was not properly connected to register vents (partially closed off). Energy loss is occurring and condensation may cause damage. Recommend repair by licensed HVAC contractor.

HVAC duct piping was not properly connected to register vents (partially closed off). Energy loss is occurring and condensation may cause damage. Recommend repair by licensed HVAC contractor.

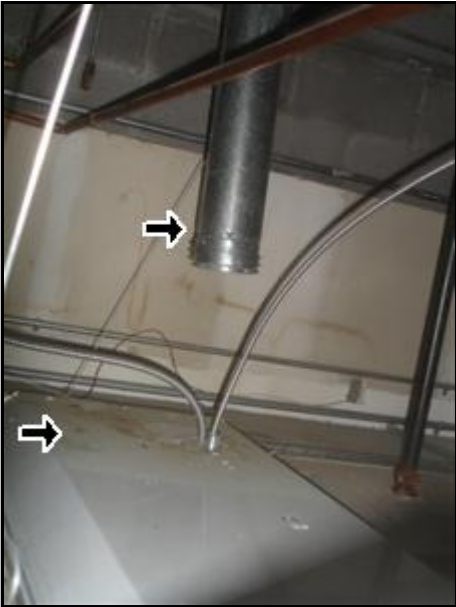
8.7 Item 1(Picture)

Flue piping was installed for a gas water heater, however an electrical water heater is currently being used. Some water stains/leaking was noted. Recommend removing or properly sealing off flue pipe by qualified contractor.
